Manhole Inspection Summary

Manhole # S53C__030MH

Insp Date: **6/13/08 12:33 PM**

Location Address: **rear 3034 e baltimore st**

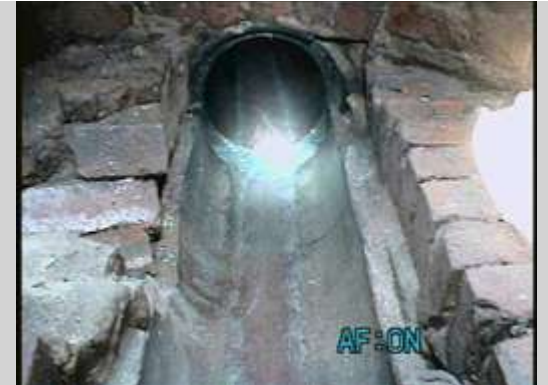
12 O'Clock Outflow

8 in. Circular Gravity Sewer
Pipe Out @ 12 O'Clock

Pipe Material: **Clay** ☐ Pipe Lined

Invert Depth: **6.98** (ft.) Flow Characteristics: **Fast**

Infiltration: **None** Pipe Seal Cond: **Unknown**

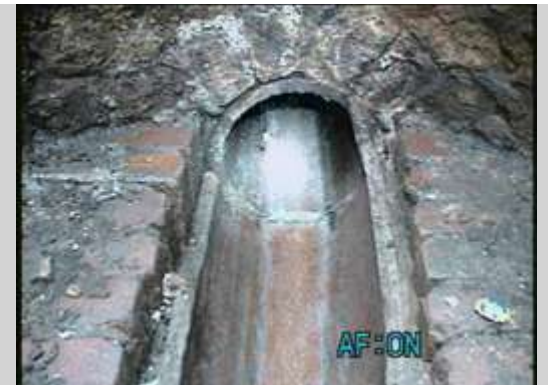
6 O'Clock Inflow

8 in. Circular Gravity Sewer
Pipe In @ 6 O'Clock

Pipe Material: **Clay** ☐ Pipe Lined

Invert Depth: **6.83** (ft.) Flow Characteristics: **Fast**

Infiltration: **None** Pipe Seal Cond: **Unknown**

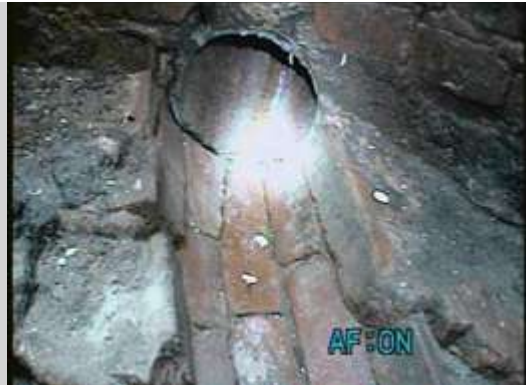
9 O'Clock Inflow

8 in. Circular Gravity Sewer

Pipe In @ 9 O'Clock

Pipe Material: **Clay** ☐ Pipe Lined

Infiltration: **None**
